X-ray Inspection of MIM 418 Superalloy Turbine Wheels and Defects Analysis

Abstract: Turbine wheels produced by metal injection molding (MIM) were subjected to X-ray inspection using three different X-ray instruments, including film X-ray, real-time imaging X-ray and microfocus X-ray. One of the X-ray inspected turbine wheels was then cut and polished for defects observation using optical microscope (OM) and scanning electron microscope (SEM) equipped with an energy dispersive X-ray spectrometer (EDS). The defects existing in the blades and the center of the turbine wheels were analyzed using an analysis software. The results show that under the same testing condition, the film X-ray equipment has higher sensitivity than the real-time imaging X-ray. However, the microfocus X-ray testing is not suitable to the MIM418 turbine wheels due to low power. Nondestructive testing (NDT) and metallographic observation reveal that macro-cracks are prone to forming in the center part of the turbine wheel, and the micro-defects in term of porosity in the blade are more than in the center of the sintered turbine wheel. Although heat isostatic pressing (HIP) can significantly decrease the porosit

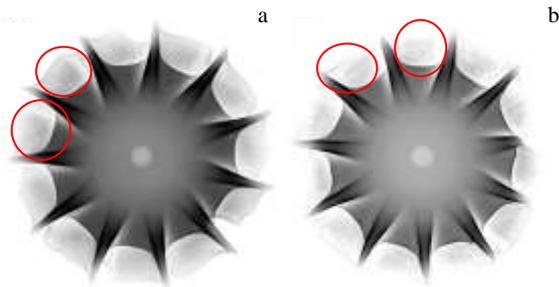
The testing results are shown in Table 1. It can be seen from this table that the transillumination direction has great effect on the detection ratio of crack, which is consistent with the observation by Tie et al^[7]. In addition, the result reveals that the crack exist in all turbine wheels using XXQ-2505, but only is found in No.2 and No.4 turbine wheels using CDZ-302P-A. These results indicate that the film X-ray testing sensitive than the real-time imaging under the same condition. The testing results obtained using microfocus X-ray equipment are given in Fig.2. Some gas pores can be seen obviously from the blades of the both turbine wheels, as marked by red circles. No defect is found

Fig.2 X-ray inspection results of MIM turbine using microfocus equipment: (a) injection molding turbine wheel and (b) sintered turbine wheel

in the center site of turbine wheels, which arises from the 0.2 mA low current, even though the microfocus X-ray equipment has very high resolution. As a result, defects in the center part of samples can't be found due to underexposure.

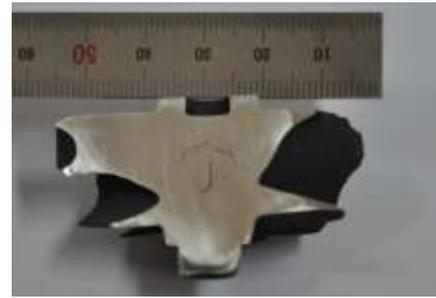
Fig.3 Sectional image of the sintered turbine

is the detection voltage. When a turbine wheel is cut into half, two cracks with sizes of about 10 mm in length and 0.3 mm in width are observed at the center part, as shown in Fig.3. After HIP, the both cracks have no healing sign. This is not consistent with the results of Zhao et al^[8]. This may arise from different crack widths in the two investigations. The critical powder loading for injection molding is 65 vol%~67 vol%, which potentially lead to significant shrinkage. The previous experiment revealed that the volume shrinkage is 12.7% after sintering due to loss of binder^[9]. The center part is about 52 mm in thickness, which is very different from that of the center part of the blade. These characters make stress distribution nonuniform within the turbine wheel at the center part. Thus, during sintering, tensile stress is evoked at the center part, which leads to crack. For the blade, the specific surface area is larger and the shrinkage is more homogeneous, so no cracks form in the blade.

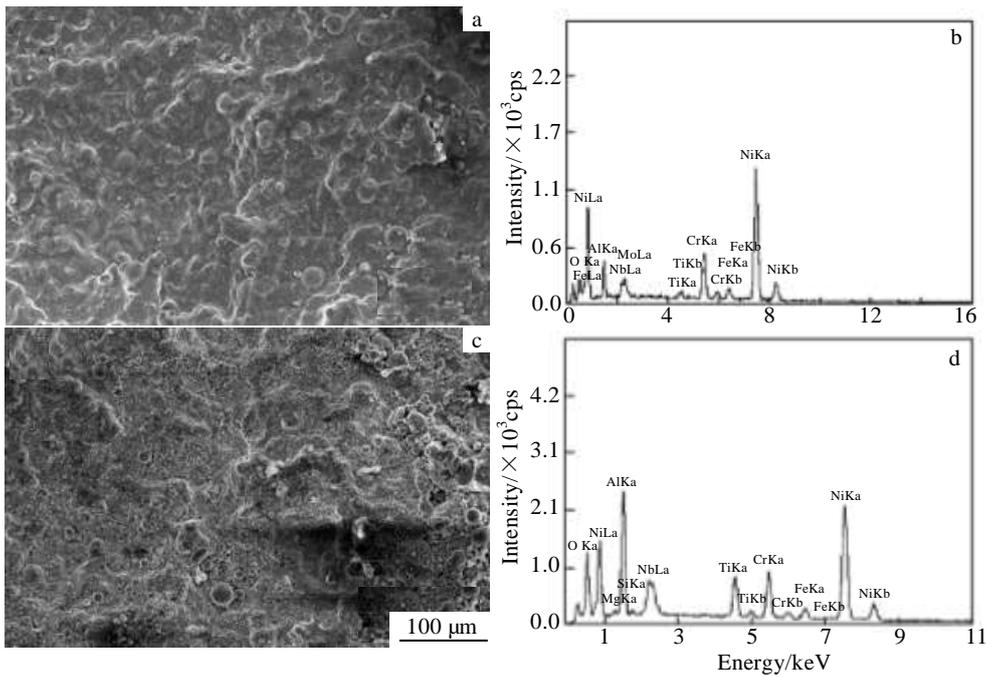
Fig.4 presents SEM morphology and EDS analysis of the crack formed in sintered and HIPed turbine wheels. EDS detects oxygen and carbon, indicating oxides existing on the crack surface, and residual of the binder. This is concluded as the sintering process is in vacuum (10^{-1} Pa). The metal powder contains Al and Ti, which is sensitive to oxygen and carbon. When sintering, it is relatively difficult to volatilize out in thick position which accelerate the oxidation and formation of crack. Once the crack forms with oxide, the following process can't eliminate the defects, and this can lead to MIM product failure directly.

Fig.4 SEM morphologies (a, c) and EDS spectra (b, d) of the crack surface at center of turbine wheel: as MIMed (a, b) and as HIPed (c, d)

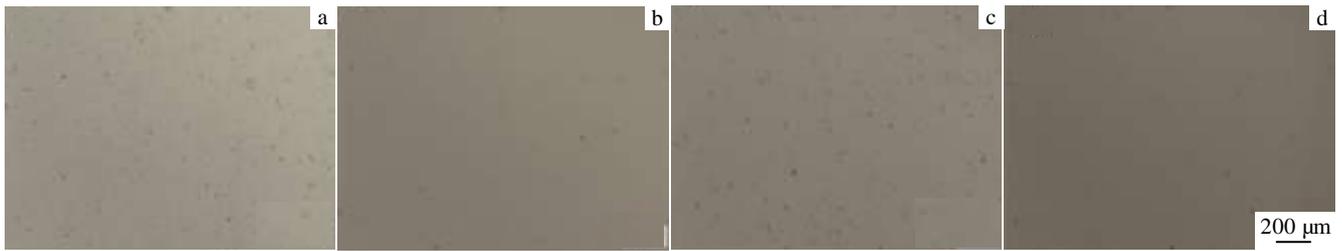
OM investigations indicate that the sintered sample has a high level of porosity, and the porosities are almost spherical, as shown in Fig.5. After HIP, density of the porosity decreases significantly, even almost disappears. This result is consistent with the mass density inspection for the samples before and after HIP. The relative density is 95% before HIP and then increases up to 97% after HIP. 10 photos taken from the samples after sintering were subjected to statistical analysis. The results reveal that the defect area fraction of the center site is about 0.31%, and that of the blade is about 0.48%.

Fig.5 OM images of the samples taken from MIM turbine wheels: (a) center site of the sintered sample, (b) center of the sintered & HIPed sample, (c) blade of the sintered sample, and (d) blade of the sintered & HIPed sample

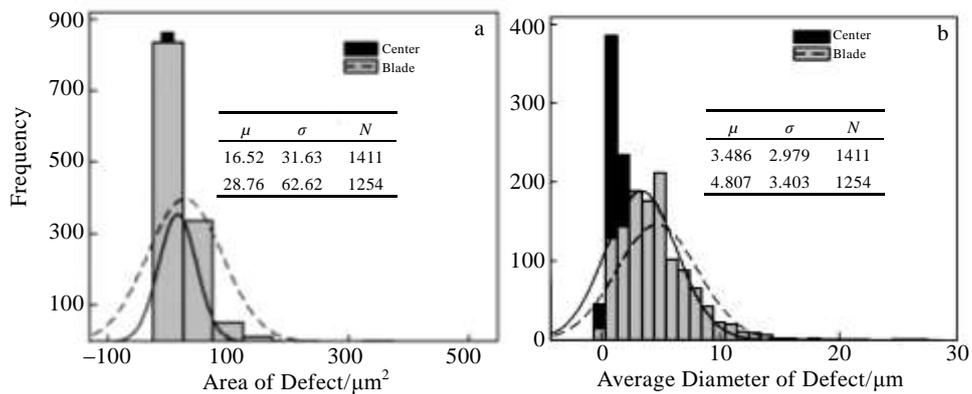
Fig.6 Statistical analysis of defects in sintered sample: (a) defect area and (b) average diameter of defect (μ -average; σ -standard deviation; N -amount of defects)

The size and area distribution of defects are shown in Table 2 and Fig.6. It can be seen that the blade has higher porosity than the center, and the defect in blade is slightly larger than that in the center. It is worth noting that some

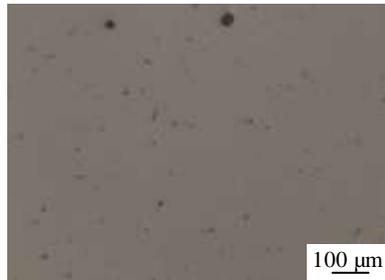
defects are very large in the blade (Fig.7), but the very large defects are not found in the center. The nature of defect distribution difference in the center and blades is attributed to two reasons. Firstly, slight separation can occur between

Fig.7 Abnormal defect existing in blade after sintering

the metal powder particle and the binder, resulted from frictional force between powder particle, binder and mold. This kind of separation is more serious than that in the blade, which can lead more binder and less metal powder to inject into the blade, so more pores and very large defects are formed, compared with the center part. The other reason is that fluid front is easier to entrap gas, and then flows into the blade during injection molding process, which is verified by X-ray inspection.
