Cite this article as: Wang Ben, Wang Yufeng, Zhao Hua, et al. Effects of Cutting Temperature on CFRP Subsurface in Drilling Process[J]. Rare Metal Materials and Engineering, 2022, 51(05): 1613-1619.

Effects of Cutting Temperature on CFRP Subsurface in Drilling Process

Abstract: The effect of cutting temperatures on the hole quality in multi-layered carbon fibre reinforced polymer (CFRP)/Ti stacks was investigated. The cutting force, cutting heat, hole surface, and subsurface quality of CFRP during drilling with and without Ti alloy supporting layer were analyzed, and the evaluation method for subsurface damage was proposed. The results show the cutting temperature and subsurface quality are greatly influenced by the existence or absence of Ti alloy supporting layer, whereas the cutting force and surface quality are slightly affected. A large amount of cutting heat is generated during cutting process of CFRP and Ti alloy simultaneously, resulting in the significant increase in temperature at the exit part of CFRP holes. The high temperature reduces the rigidity and bonding performance of CFRP resin matrix, leading to serious subsurface damage of the fibre layers around the exit pa

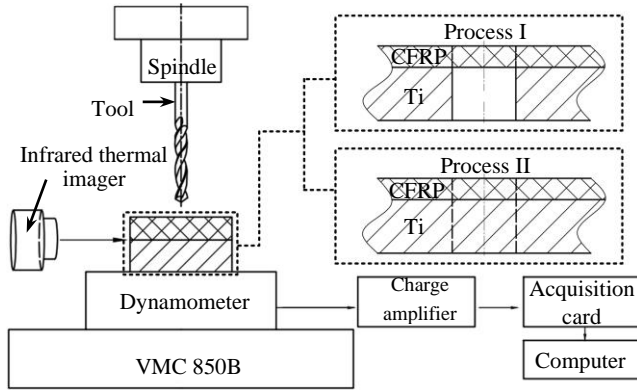
Fig.1 Schematic diagram of drilling processes

A VMC850B numerical control process centre was used. The coolants were not used in this research to eliminate the influence of cooling liquid. The Ti alloy supporting layer can increase the quality of the exit part of holes in the composite during the drilling of CFRP/Ti stacks. Therefore, the drilling of CFRP and CFRP/Ti stacks, namely Process I and Process II, respectively, was conducted. Process I included the pretreatment of a through-hole of $\Phi 6$ mm in the Ti alloy plate. Then CFRP plate was placed on the Ti plate and machined under the same conditions as the pretreatment of Ti plate, i.e., the drilling without Ti alloy supporting layer was conducted in Process I (Fig. 1a). Process II included the drilling of CFRP/Ti stacks in a single process, namely the drilling with Ti alloy supporting layer (Fig. 1b). The drilling parameters are shown in Table 2. Seven groups of tests in total were conducted in this research.

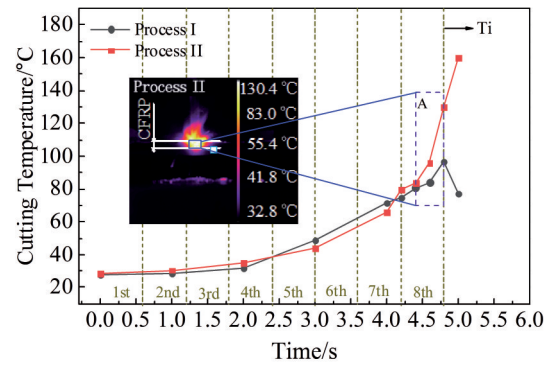
Fig.3 Cutting temperatures of CFRP drilling with and without Ti alloy supporting layer

The cutting temperature of CFRP/Ti stacks during drilling is shown in Fig. 3. During Process II, the maximum cutting temperatures at the exit part of CFRP hole reaches 130.3 °C, which is about 35.5% higher than that during Process I (96.3 °C). Additionally, the cutting temperature of 8th fibre layer is 12.5% and 26.9% higher than that of 7th fibre layer during Process I and Process II, respectively. Hence, the cutting temperature is increased more with the presence of Ti alloy supporting layer.

During the drilling of CFRP/Ti stacks, CFRP and Ti alloy are almost simultaneously drilled at the interface of CFRP and Ti alloy. The change in cutting temperature at this stage is shown in zone A in Fig.3. Clearly, the two processes produce different cutting temperatures in zone A. The cutting temperature during Process II increases abruptly. Besides, the cutting temperature of Ti alloy is obtained after the drilling of 8th fibre layer, i.e., after drilling for 4.8 s.

It can be seen from Fig.3 and Fig.4 that the surface quality of hole walls is relatively good at the 1st~7th fibre layers. The cutting temperature is low during the drilling of these layers and there are no significant differences in the damage degree among these layers. Hence, the subsurface damage caused by

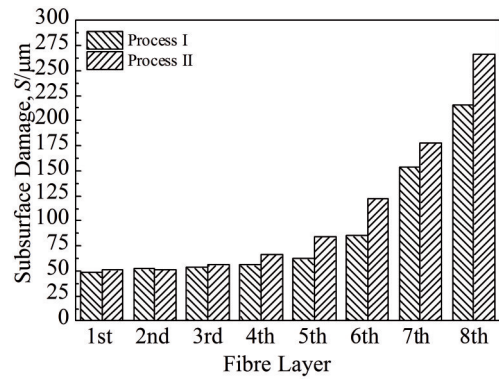
Fig.8 Subsurface damage S of each fibre layer of CFRP after different processes

where d_i is the damage depth at i layer of a certain cutting angle; n is the number of different cutting angles. This research applied 8 cutting angles ($n=8$): $\theta=0^\circ, 45^\circ, 90^\circ, 135^\circ, 180^\circ, 225^\circ, 270^\circ, 315^\circ$. Fig. 8 shows the subsurface damage S of each fibre layer of CFRP after different processes.

increased exponentially. The damage degree of fibre layers is increased with approaching the hole exit. The subsurface damage of the 8th fibre layer is 33% and 48% higher than that of the 7th fibre layer after Process I and Process II, respectively. Moreover, the subsurface damage of the 8th fibre layer after Process II is 31% higher than that after Process I; the subsurface damage of the 7th fibre layer after Process II is 18% higher than that after Process I. Therefore, the variation in subsurface damage on fibre layers is basically consistent with that of the cutting temperature. Therefore, the subsurface damage in CFRP after Process II is worse than that after Process I.
